# **Low Discharge/Streamflow Rate Below El Vado Dam** **Chama River, New Mexico ~ January 1<sup>st</sup>, 2012**

## ***Observations of the effects of lowered water levels on the brown trout redds (spawning beds).***

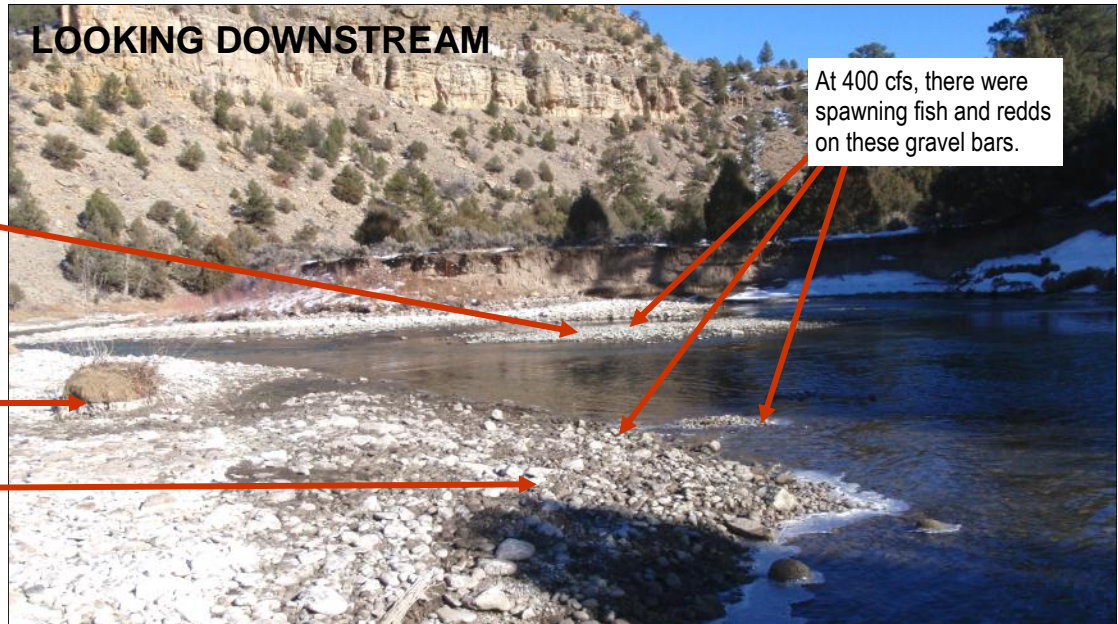
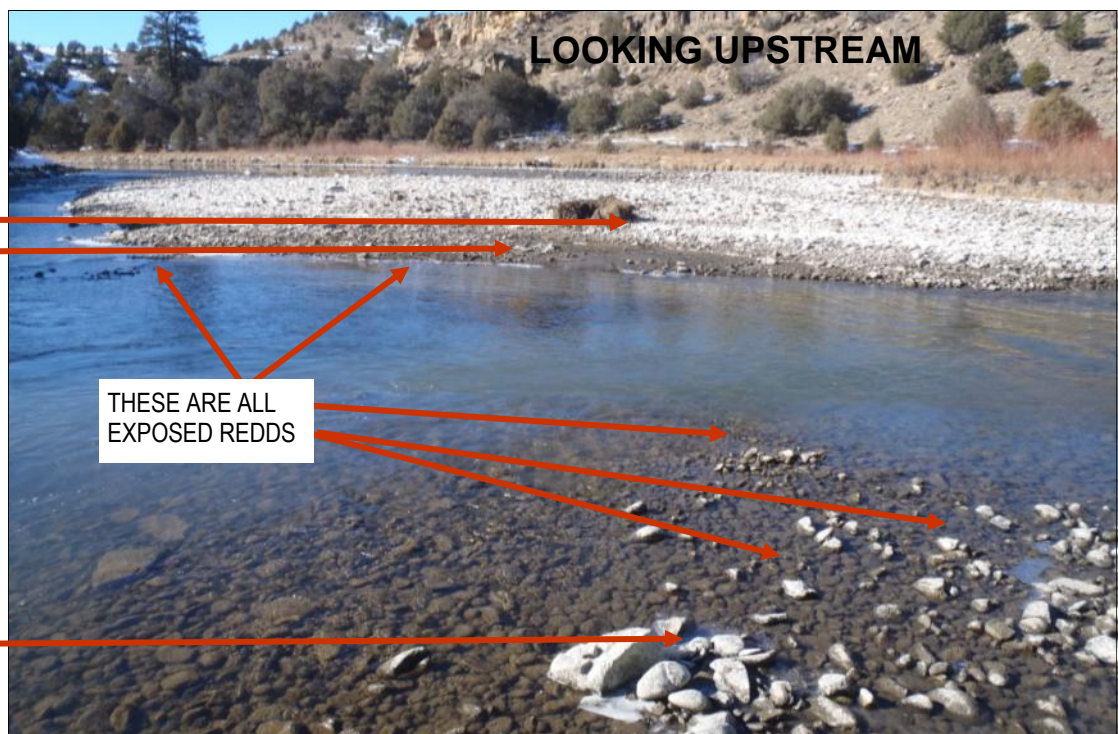
## Area 1

This section of the river is one of the most heavily utilized areas for brown trout spawning and redds on the Chama River. In this area, during the time period in November and December when the streamflow/discharge was at 400 cfs, we observed large numbers of spawning brown trout. At this higher flow level (400 cfs), a large number of the redds were way up on the gravel beds, close to the water's edge. Due to the reduction of the water flow/discharge to 42 cfs, many of these redds are now dried out or in very shallow, stagnant water. Some of the redds that are in the shallow water are covered with ice due to lack of water movement. All the photos below were taken on January 1<sup>st</sup>, 2012 with streamflow/discharge from the dam at 42 cfs. At 400 cfs, there was up to 16 inches of water covering the exposed gravel bars in the photos below.

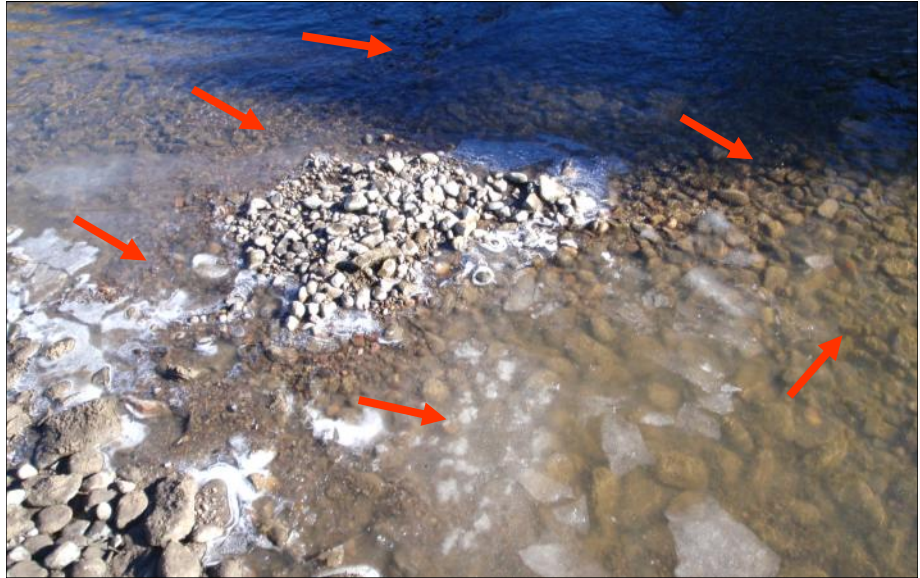
This gravel bar was covered with 14 to 16 inches of water at 400 cfs. There were many brown trout spawning and redds on it. Now at 42 cfs, the bar is mainly dry or covered with 2 to 3 inches of water. As well, due to the reduced water levels and less velocity of flow, there is substantial ice formation as well. Note: this photo was take at 2:15 in the afternoon. The ice is substantially thicker in the night and early morning hours.

The arrows are pointing to existing redds.

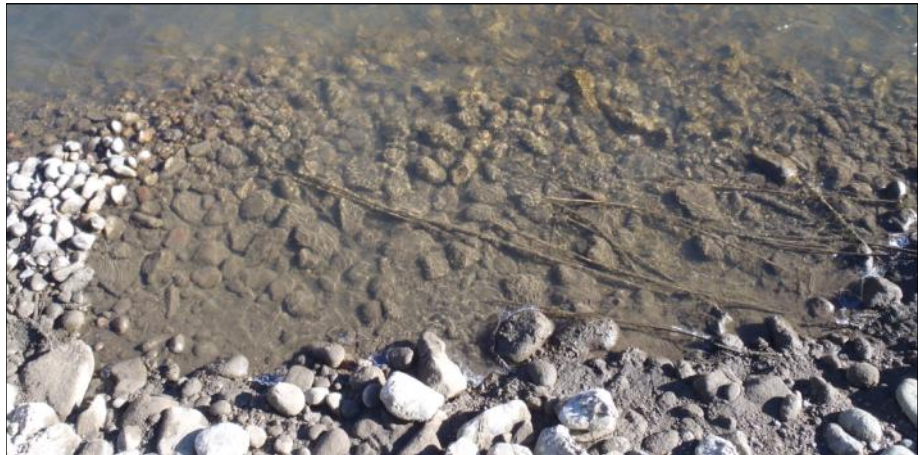
This image shows a redd that has been almost completely exposed by the reduced flows. At 42 cfs there is a maximum of 2 inches of water covering the redd, at its deepest point. As well, with the lack of water flow velocity, this spawning bed has begun to silt in and the gravel is no longer clean.

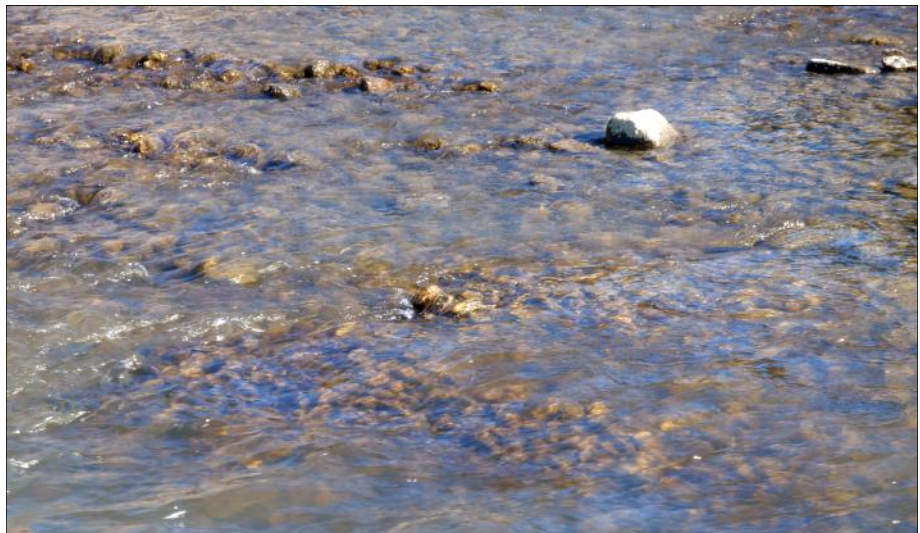
This gravel bar was covered with 16 to 18 inches of water at 400 cfs. It is completely covered with brown trout redds (note the many depressions and patches of finer, clean gravels). As one can see, now at 42 cfs, there are many exposed spots on the bar and there is very little water flow over the rest of it. Though not completely dry, these redds are at the risk of exposure to freezing, lowered oxygenation, silting and predation.

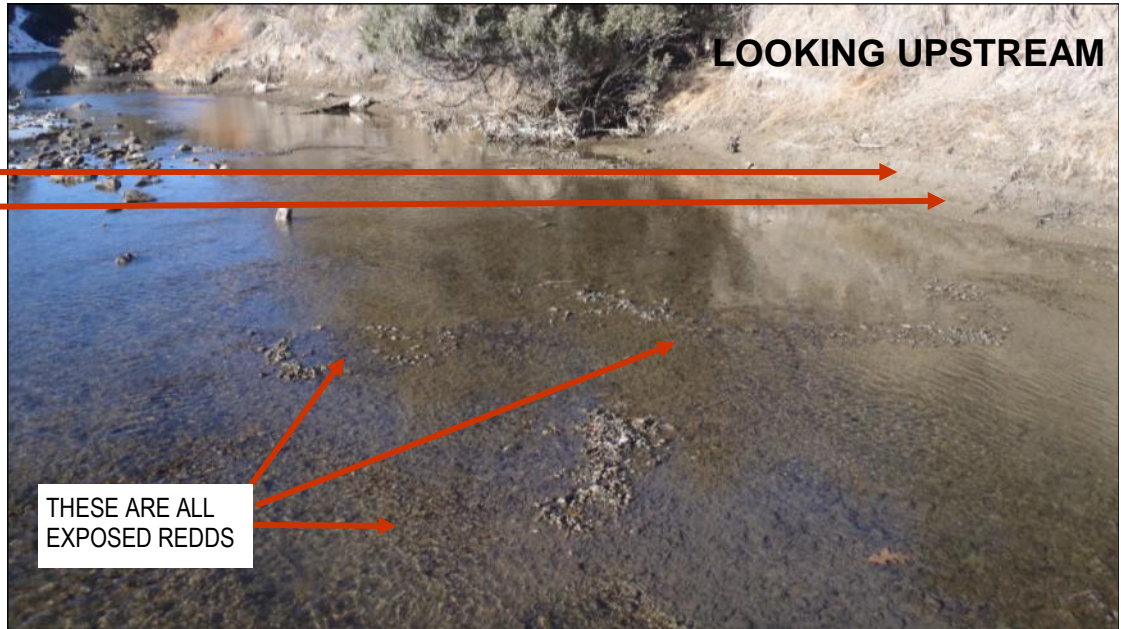
This this is the approximate water height at 400 cfs.

This this is the approximate water height at 100 cfs.

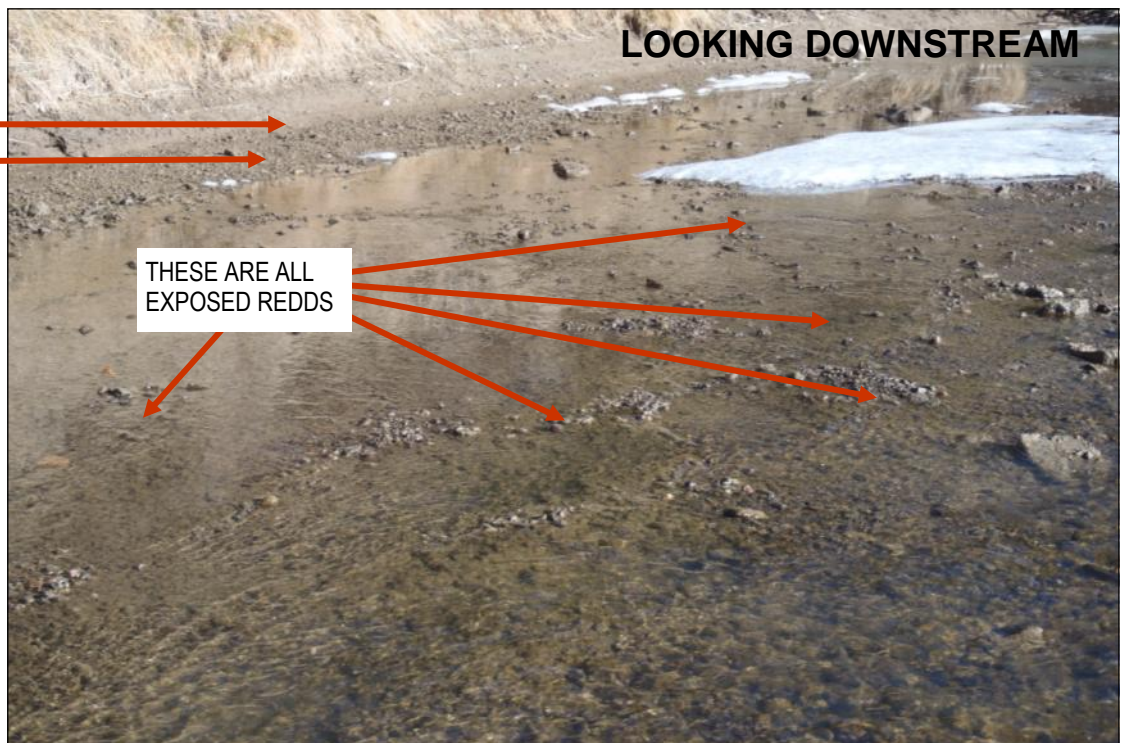
This this is the approximate water height at 400 cfs.

This this is the approximate water height at 100 cfs.

Note the ice and snow sheet sitting on top of the gravel bar. At 400cfs, there was a fair amount of current and 12 to 14 inches of water flowing where the ice and snow sheet is now.

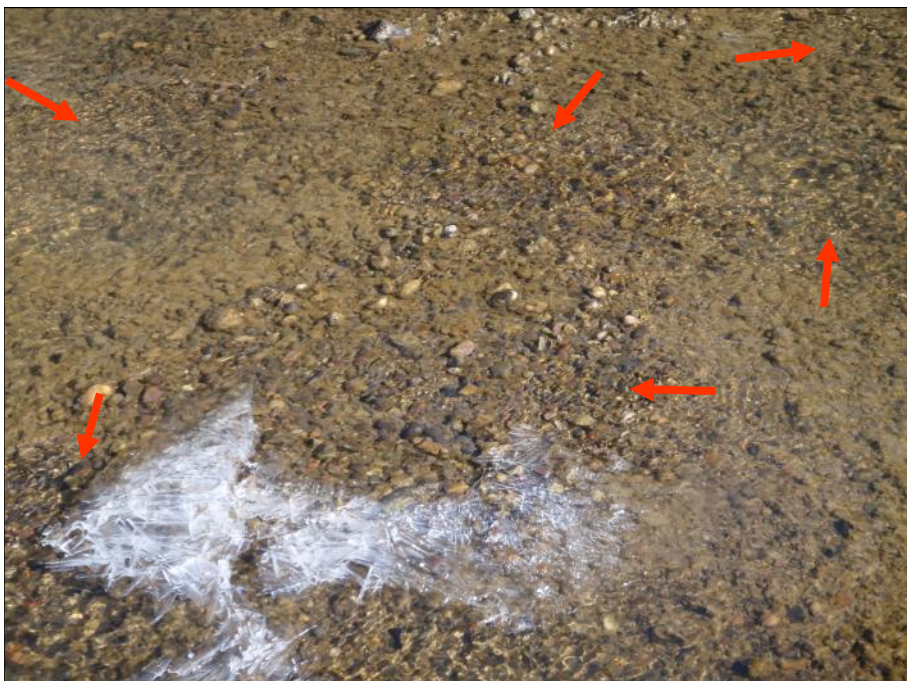
This photo shows the perfectly cleaned patches of gravel of 6 separate redds (Note where the arrows are pointing). When the brown trout made these redds, there was about 12 to 14 inches of water flowing over them. As one can see, now with the water flow/discharge at 42 cfs, there is no more than 1 to 2 inches of water over them and many of the slightly higher spots are now completely out of water. As well, with the water flow and depth so greatly reduced, ice is forming on the higher areas. This picture was taken at about noontime. Quite possibly during the night, this area could be completely iced over.

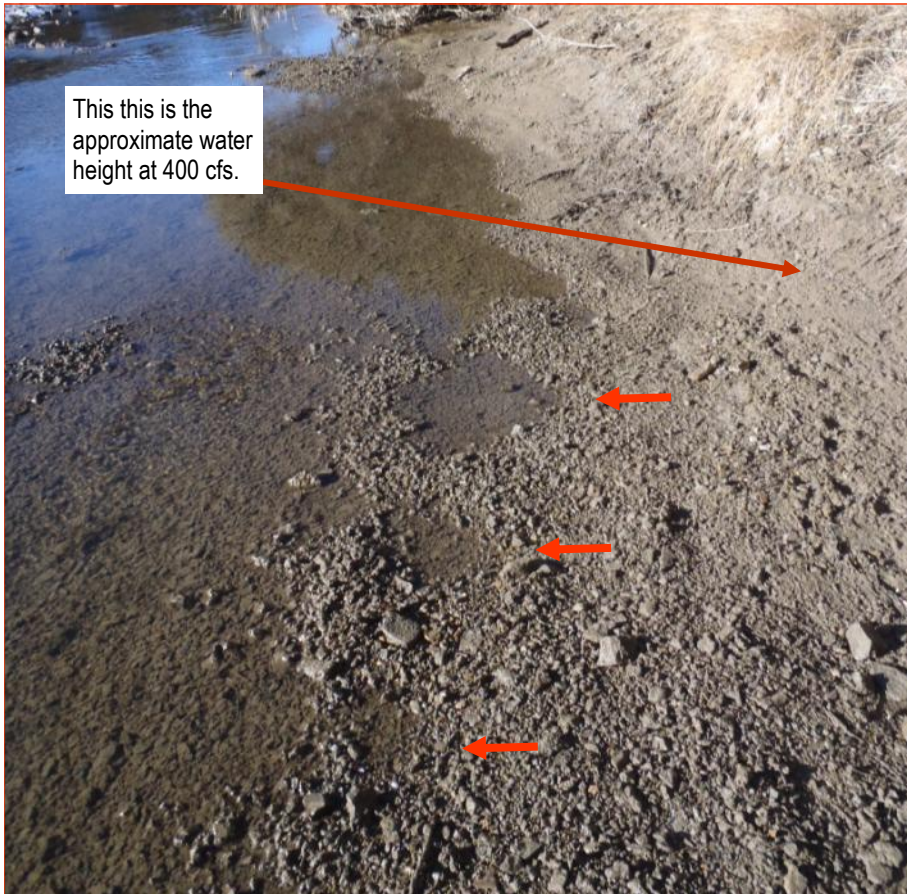
This photo shows 3 completely exposed redds (Note where the small arrows are pointing to the depressions in the river bottom at the lower/center part of the picture). As in the photo above, when these spawning beds were made, there was about 12 to 14 inches of water flowing over them. With the current water flow/discharge at 42 cfs, these redds are basically "high and dry". This photo is a perfect example of what happened this spawning season. At the higher streamflow/discharge of 400cfs, the brown trout moved up into areas where there was great "spawning gravel", made their redds and deposited and fertilized their eggs. Unfortunately these fish were unaware that the streamflow/discharge would be reduced by approximately 90% (400 cfs down to 42 cfs) within a few weeks after they had spawned.

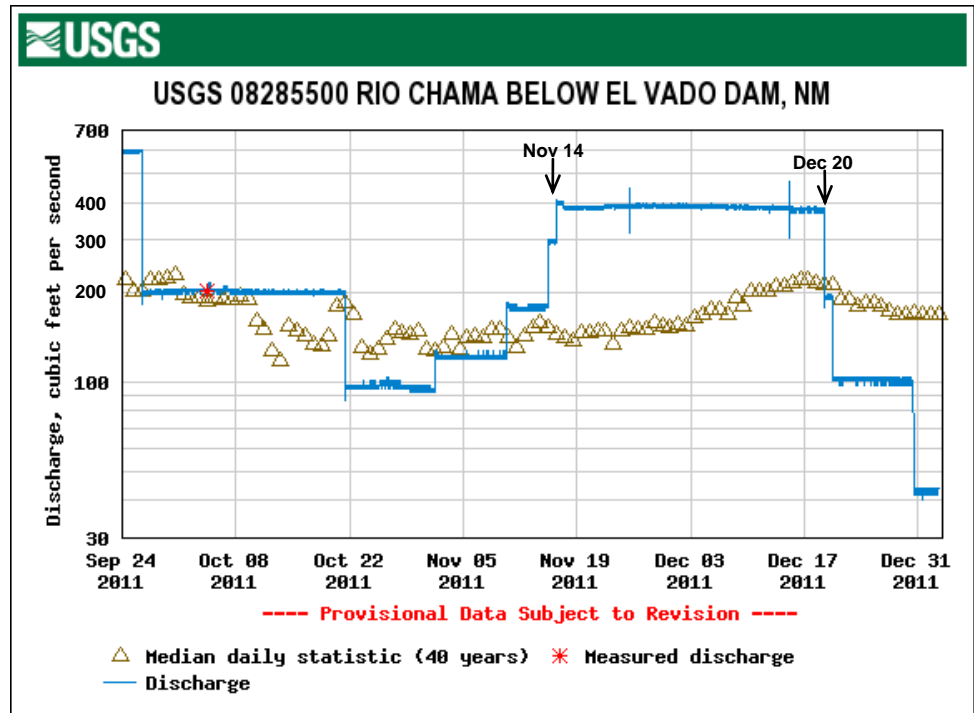
This graph shows 100 days of discharge rates for the time period from September 24<sup>th</sup>, 2011 thru January 2<sup>nd</sup>, 2012 (100 days). This time period covers the full extent of the spawning season for brown trout on the Chama River below El Vado Dam. The height of the spawning season, when the fish are up on the redds, is typically from the latter part of October through the end of December. The increase in streamflow/discharge to 400 cfs occurred on November 14<sup>th</sup>, 2011 and was held there steadily until December 20<sup>th</sup>, 2011. This 35 day period of 400 cfs occurred through the most intense period of the brown trout's spawning cycle. It is interesting to note that the median flows (a 40 year average) for the same time period are consistently between 120 cfs and 220 cfs.

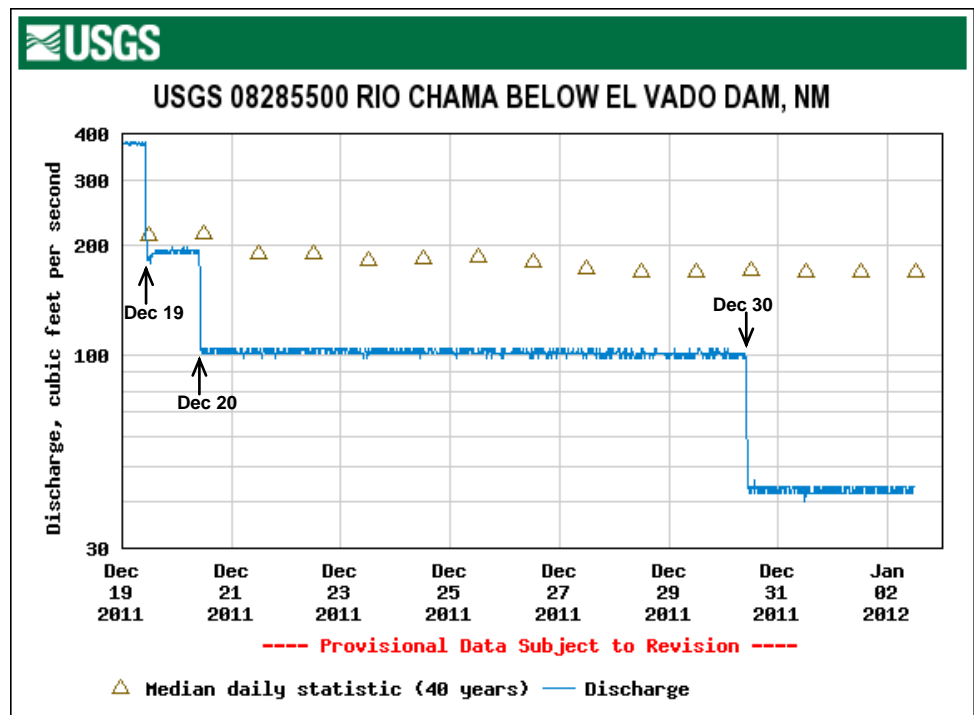
This graph shows 14 days of discharge rates for the time period from December 19<sup>th</sup>, 2011 thru January 2<sup>nd</sup>, 2012 (14 days). This is when the streamflow/discharge was decreased from the 35 day period of 400 cfs to the December 30<sup>th</sup>, 2011 amount of 42 cfs. It is interesting to note that on December 19<sup>th</sup>, the streamflow/discharge was cut by 50% from 400cfs to 200 cfs without any ramp-down. December 20<sup>th</sup>, it was cut again to 100 cfs creating a 75% total reduction of streamflow within a 24 hour period. Then on December 30<sup>th</sup>, the streamflow/discharge was reduced to 42 cfs. This added up to a 90% total reduction in streamflow/discharge within 11 days - directly after the brown trout spawning cycle was finished.
